The Tsakona landslide in Peloponnese – Greece

G. Dounias, *Edafos Consulting Engineers S.A., Greece*

G. Belokas, *Public Power Corporation S.A., Greece*

EXTENDED ABSTRACT

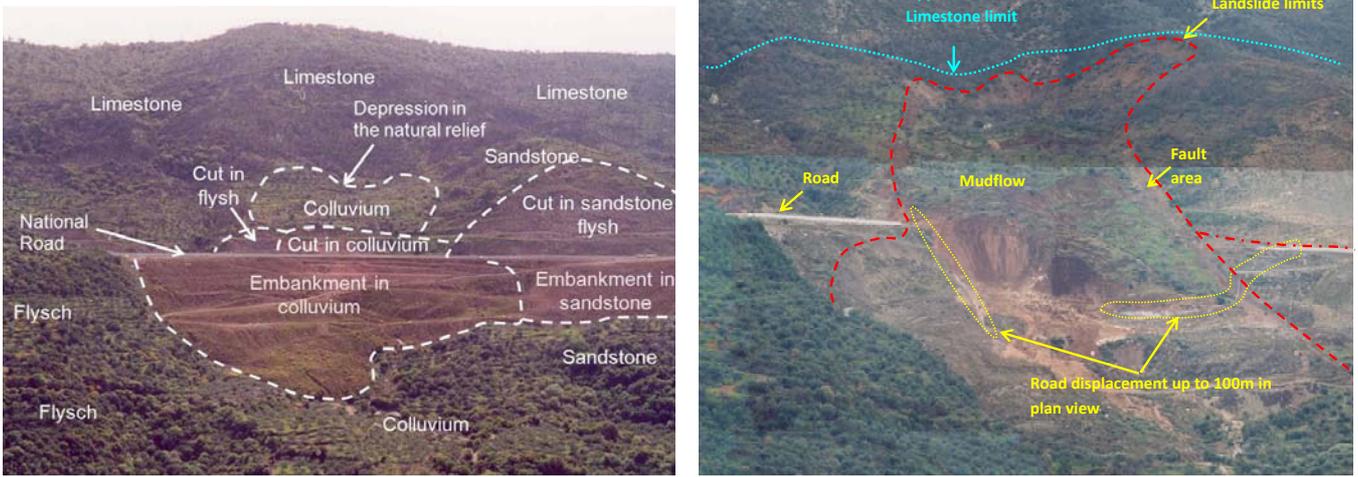
In February 2003 a large landslide (Figure 1) occurred at a freshly operated national road at the central part of Peloponnese, which involved the fast movement of approximately 6,000,000 m³ of soil disrupting completely the traffic. Notably, over about 200m the highway slipped for approximately 100m in plan and about 40m vertically. The landslide was destructive, altering the landscape in an area of 400m upslope and 700m downslope, resulting in a series of cracks of large width and depth, an altering of the streams flow, the creation of ponds, the destruction of agricultural roads and hamlets, etc. The road reconstruction, which includes a long bridge, has not yet been completed.

Figure 1. General view of the landslide area a) before final triggering and b) after final triggering (including a disruption of the National Road between Ch. 16+300 and 16+600).

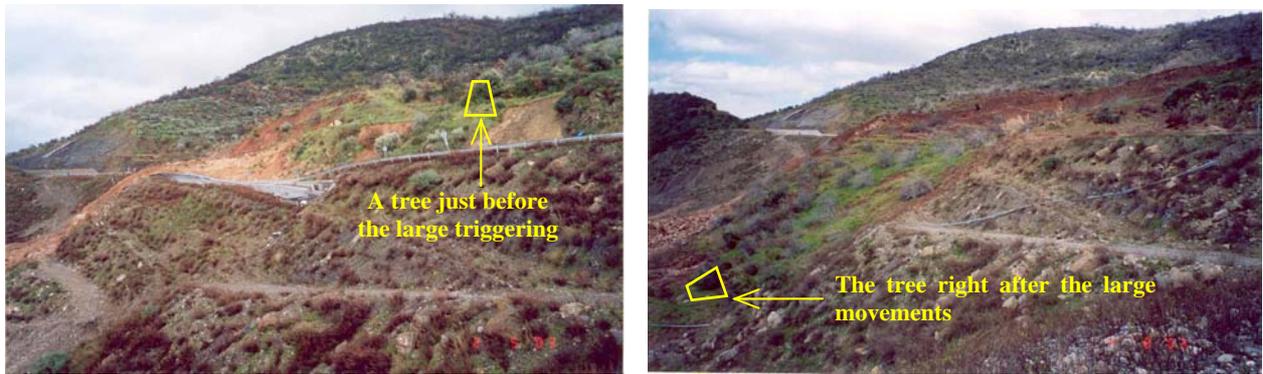
Figure 2. Landslide development (view from south to north, i.e. towards Tripoli) (from Dounias *et al*, 2006).

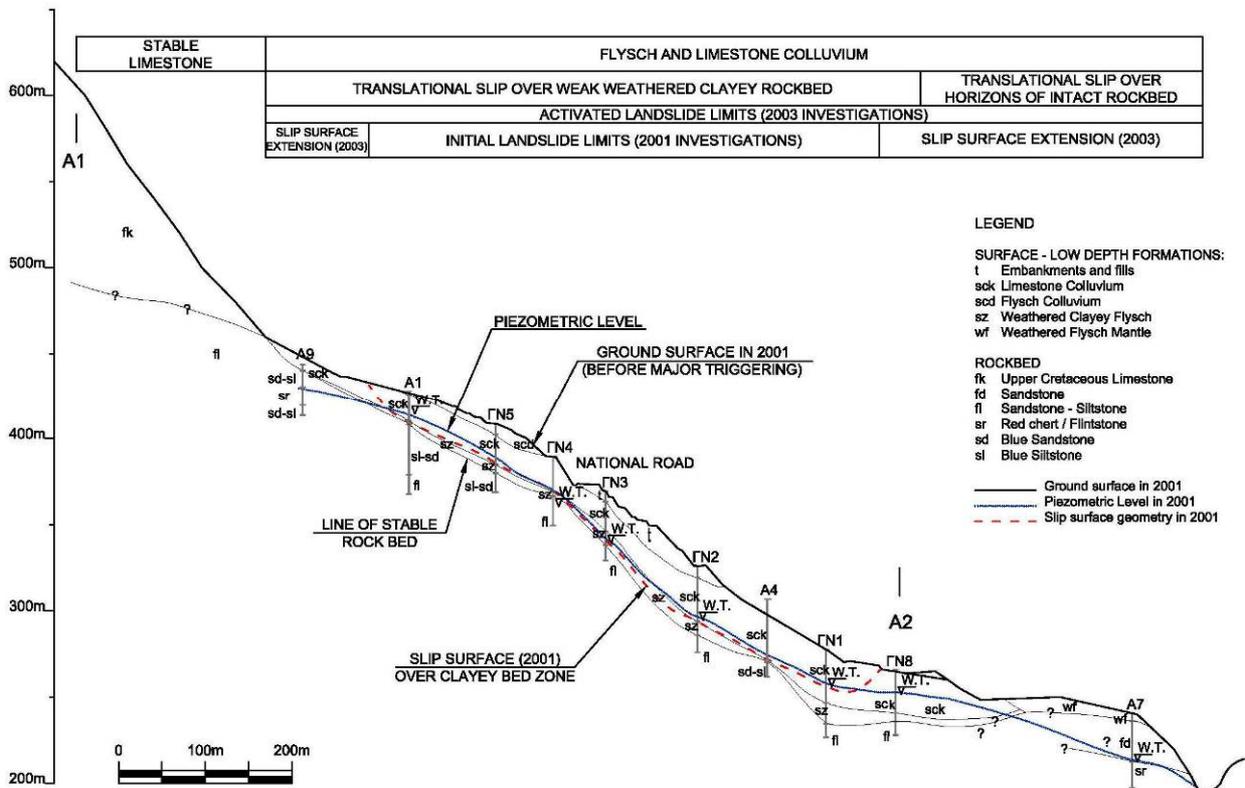
The sliding became visible on the pavement shortly after the opening of the national road in year 2000. In 2001 a geotechnical investigation revealed that the instability was not restricted within the road earthworks but involved a greater area of about 800 m length and 6,000,000 m³, which could, under certain circumstances move disrupting the traffic. Moreover, a careful appraisal of the geomorphology revealed that the landslide was pre-existing. The slip surface was found to follow the interface between the deep colluvial material covering the slope and the bedrock. The maximum depth to the slip surface was 20 to 35 m. In January 2003, after a very intense rainfall period, a considerable settlement of the pavement was observed right above the axis of one of the two culverts crossing the road embankment. Soon the settlement was enlarged and became a “crater” with a progressively enlarging diameter, while rapid widening of the pavement cracks was observed. In addition, the water flowing through the drainage culverts and the water outflow from local “springs” had been appreciably increased. Finally, the large activation took place in February 2003. This included a surficial earthflow-mudflow (Figures 1 and 2) and a huge thrust downhill, expanding the limits of the landslide which reached down to the riverbed (Figure 3), blocking locally the flow of a the river.

Figure 3. Cross section of the slip surface in 2001 along axis shown in Fig. 8 (from Belokas *et al*, 2013).
