Slopes Instability along an International Road in North Africa

ABSTRACT:

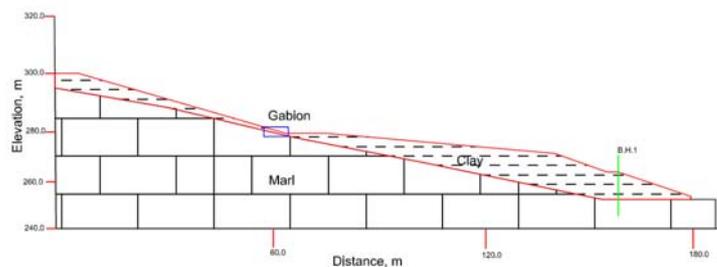
The ground conditions are almost similar to great extent in most of the landslides areas. Figure (1) shows a cross section and geotechnical stratification of one of the slide areas. The landslide area in Figure (1) consists of clay/silt/sandy colluviums layer that is underlain by marl.

Figure (1): Cross Section of the Slope and Stratification at one of the landslides areas along the road.

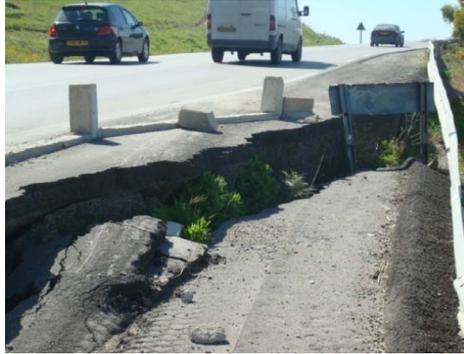
- 1) Surface cracks starting from the road level
- 2) Steps of settled area at the edge of the road showing the start of deep sliding surface (Fig. 2)
- 3) Surface scarp areas and
- 4) Previous attempts for slide stabilization including gabions that are sometimes seem to be not efficient.

Figure (2): Site evidence of instability at one of the landslides areas along the road

The presence of the clays and/or colluviums deposits over marly rocks as observed and reported in above are the main explanation for the failure. At the described sliding area, the slip surface starts from the cracks at the edge of the road and extends down to the interface between the Clay and the Marly rock. The slip surface follows the Clay-Marl interface down to the toe of the slope below the existing Gabions to the surface. The geometry of the slip surface at the sites are confirmed based on boreholes drilling and dynamic penetration resistance profiles that are carried out in the areas for the sake of characterizing the geometry of the slip surface and to characterize the stratification in the slope areas.

The main reason for the slides could be due to the rise of ground water at rainy season. Such a rise increases the water pressure resulting in a decrease in the effective normal stress along the slip surface. The decrease in effective stress leads to a decrease in the shear strength of the geomaterial along the slip surface.
