CONCERNING LANDSLIDES IN THE WEST OF ALGERIA: PRESENTATION OF SEVERAL CASE STUDIES

This article deals with the vulnerability of some sites prone to complex problems of instability of slopes, located in the west of Algeria. We wish to report five cases of movement slopes, which emerged in the Algerian West under the influence of several factors that intervened in the affected environment sites (rainfall, geology, human factor, etc...).

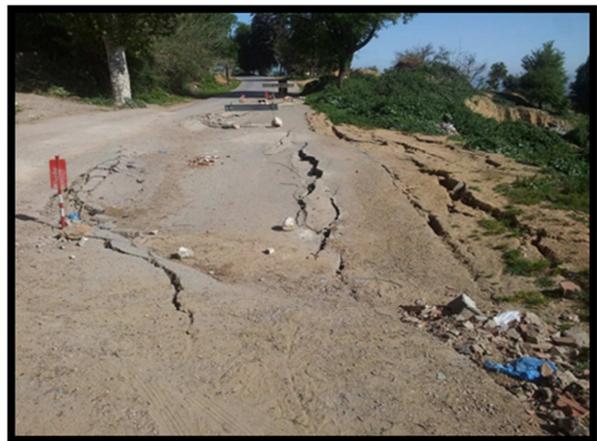
Case 01 Landslide at the national road n°05 i.e. at the East side town limit of Ouled Mimoun – Tlemcen, Algeria

The site is made of greenish, very thin marls, running on surface and including sandstone intercalations in the form of thin benches and allotted stratigraphically to Miocene. This unit is pressed on the Jurassic massif. It is surmounted by formed loose embankments made of marls and heterogeneous blocks, such as plio-quadernary pudding stones and travertines, earlier deposited by water sources.

It is a small landslide that may be described as being plane and partially rotational. It

occurred precisely as two small bands quite distinct from the roadway n°05 and its east downstream verge. This slide is generally established on a road linear that approximates 50.0m.

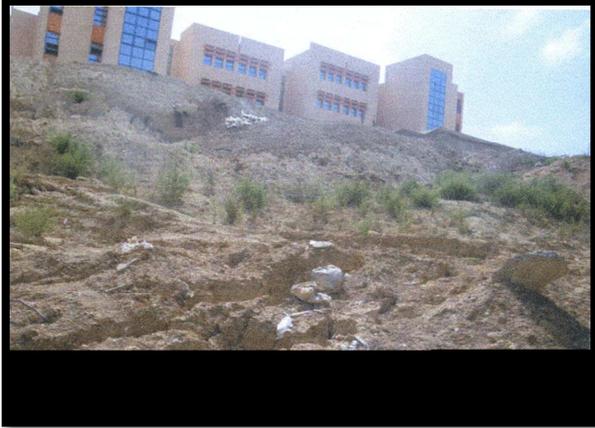
Case 02 Landslide of the new university center in Mansourah-Tlemcen, Algeria

The landslide zone located at the North-west limit of Tlemcen perimeter is characterized by formations allotted stratigraphically to Miocene and represented by a powerful greenish layer of marl with thin detrital intercalations (sandstone and sand). The whole is completed by embankments (marls, clays, rocky fragments, construction waste, etc...) of irregular thickness, vertical cracks and presents itself sometimes in stairs (effect of the slide).

The analysis established according to the made observations from apparent aspects of geomorphological and mechanical type, allowed for slide positioning in "rotational type" (or circular) having affected the altered superficial layers. Consequently, an escarpment was generated at the slope highest point with traction cracks carrying the slipping mass on the side with a roll in foot which reversed the existing fence.

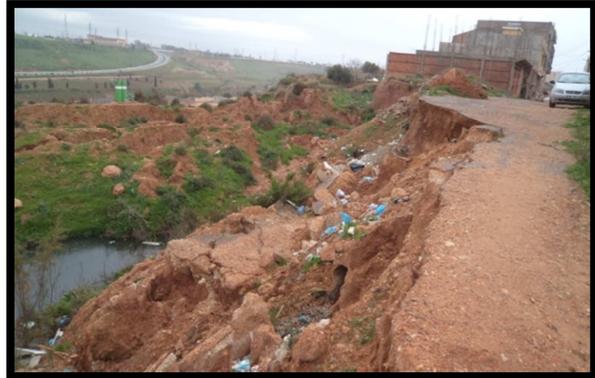
Case 03 Landslide slope of the site «Les amandiers» located in Arzew town – Oran, Algeria

On the geomorphological level, the studied area is located on the southern slope of Djebel Dar Amara which corresponds to an important basin, very spread out to collect rain water during winter. The fallen rain water was channeled by several rivers that flow on Oued EL Mohgan.

At the "Les amandiers" quarter, water flow was modified by the presence of constructions (buildings and road works). Consequently, rain water was diverged to the middle of the city slope, by sapping the poured embankments at the edge of the slope and coming from surplus clearings of the existing buildings.

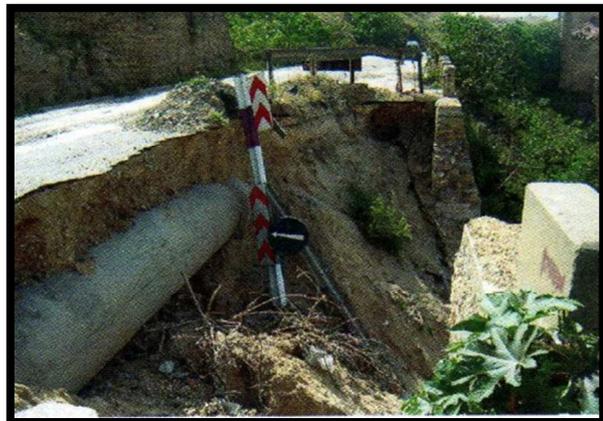
Case 04 Landslide of the local road linking the national road n° 11 to the "Plateaux district – Mostaganem, Algeria

From a paleo-geographical point of view, the site is integrated in the neogen basin of the low Chélif which presents geological formations that vary in age and lithological

facies. It is characterized by a cliffy morphology of practically vertical profile, approximately 30 m height and with heterogeneous geological composition. Falls of sandy blocks and sand collapses were noticeable on site. These two phenomena correspond to degradation processes of which origin depends on a certain number of factors, and particularly of the morphology (subvertical slope), geological structure (facies type) and sandstones deterioration and cracking, caused by climatic (rain fall) and anthropic (blocked gutter) conditions.

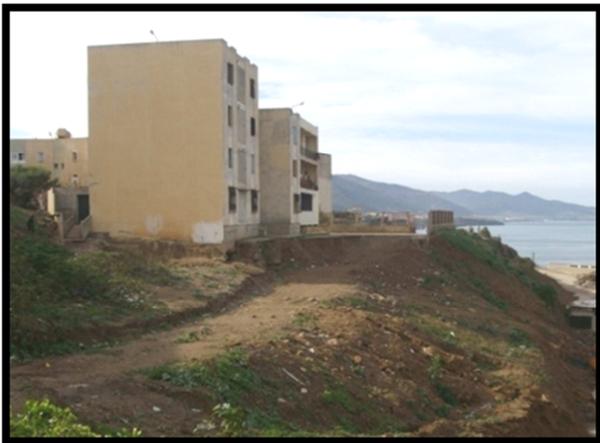
Case 05 Landslide at the north of the city of Ténès–Chlef, Algeria

The site is a 30 m height slope, skirting the sea on a 100 m distance. In the past, it has been subjected to civil engineering work, such as road and buildings construction and the installation of embankments. This has simply affected the original relief.

The study of the geological map allowed for the classification of the site on gypseous trias which is the first period of the secondary era marked by the deposit of two types of grounds, generally corresponding to the clusters of gypsum and iridescent clays.
